RESEARCH MEMORANDUM

LATERAL AND DIRECTIONAL STABILITY AND CONTROL
CHARACTERISTICS OF A C-54D AIRPLANE

Donald B. Talmage and John P. Reeder

March 24, 1949

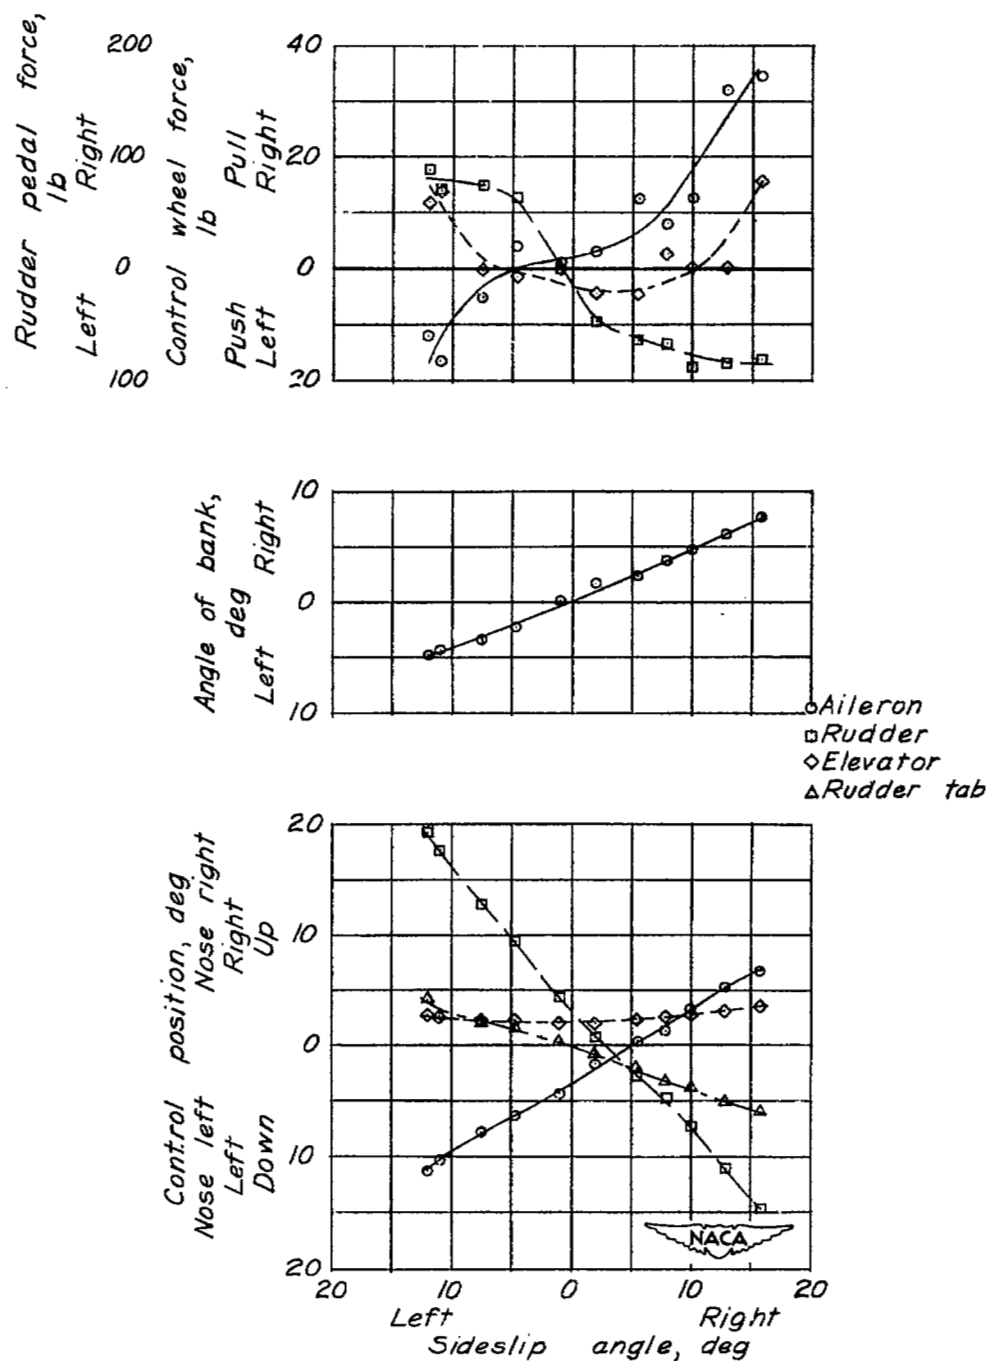
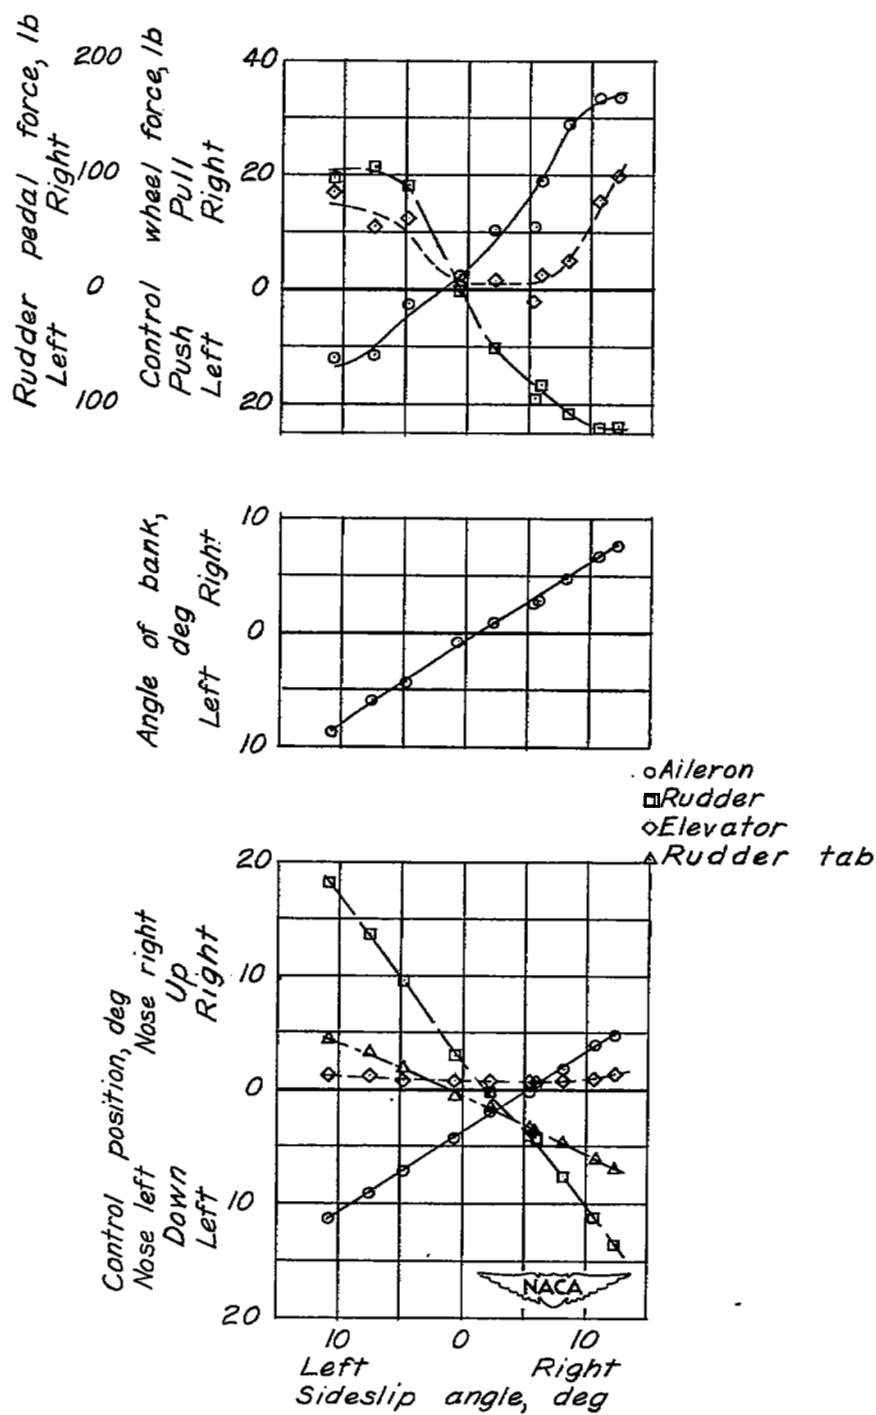
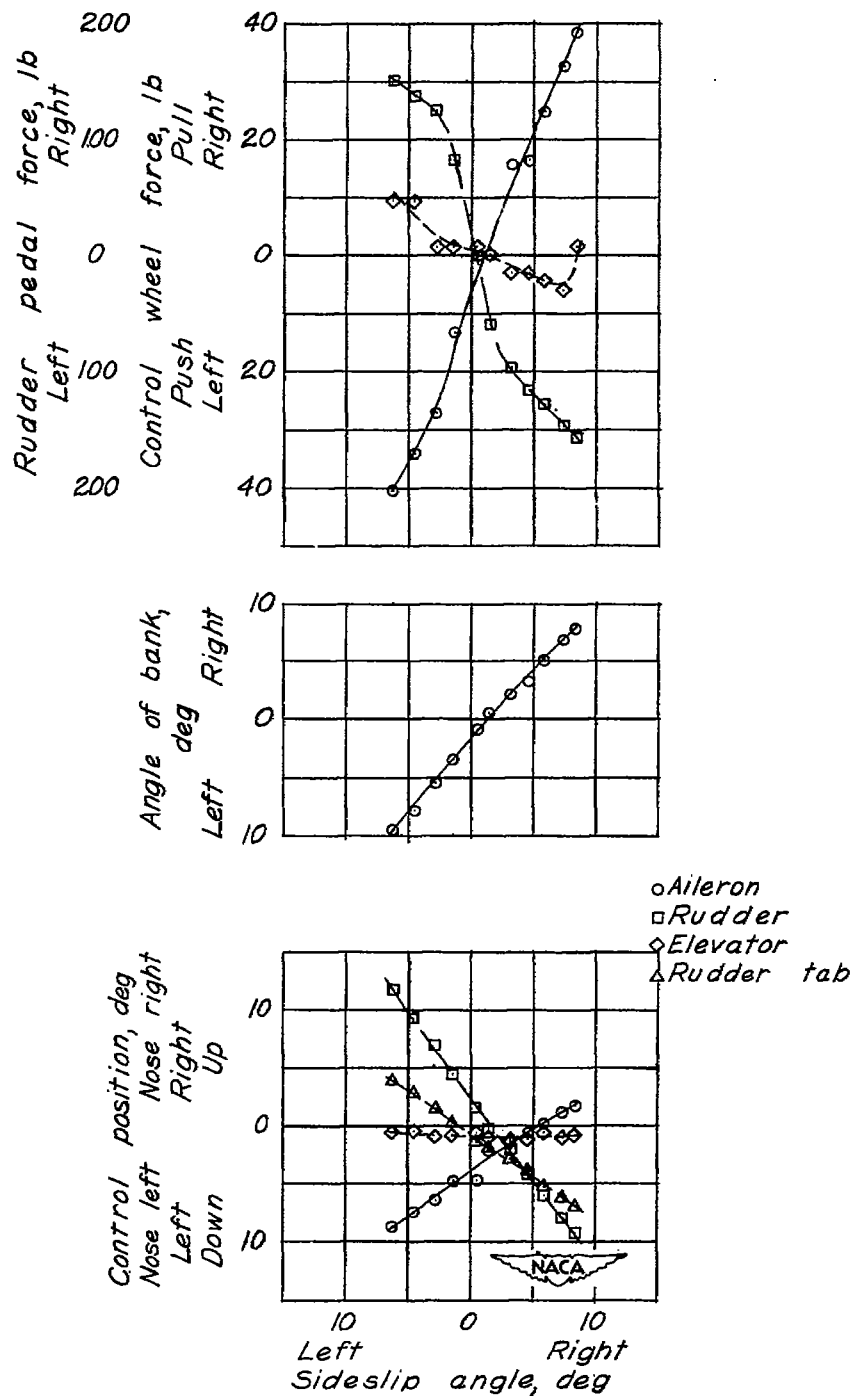
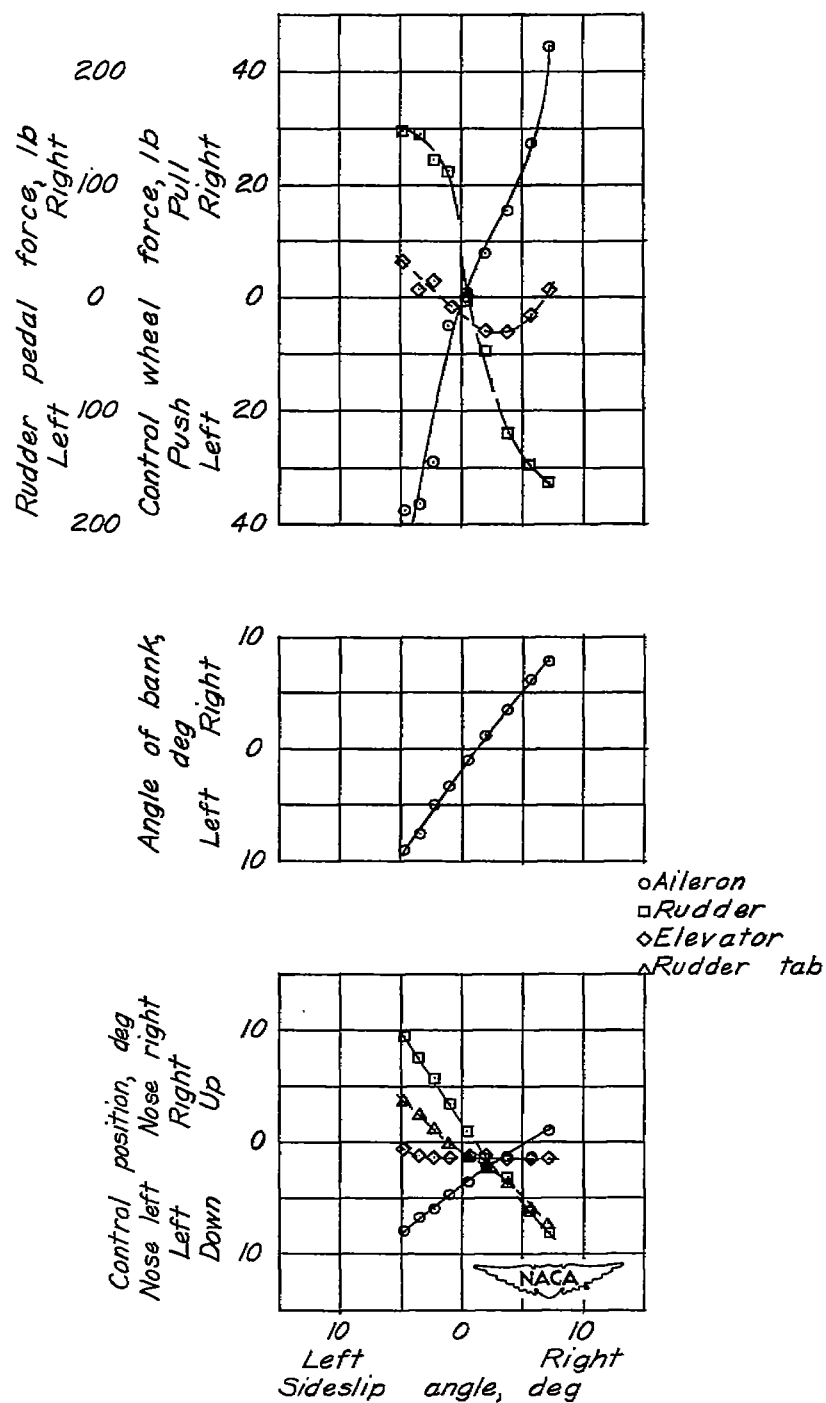
Figure 9.— Sideslip characteristics. C-54D airplane; clean condition; normal rated power.

The characteristics of the airplane in sideslip were measured in straight, steady sideslips in various flight conditions. Records were taken of the aileron, elevator, and rudder deflections and control forces, the angle of bank, and the angle of sideslip. Figures 9 through 13 show the results of these sideslips.

Directional stability.— The control-fixed static directional stability as shown by the variation of rudder deflection with sideslip angle was positive in all conditions (left rudder deflection was required for right sideslip and right rudder, for left sideslip). The sideslip angle was always proportional to the rudder deflection and therefore the requirements were met.

Dihedral effect.— The control-fixed dihedral effect as evidenced by the slope of the curve of the variation of total aileron angle with sideslip angle was positive in all conditions at all speeds. The airplane had a geometric dihedral angle of 7° and in the clean condition power off, the effective dihedral angle was 4.7° throughout the speed range. The effective dihedral was slightly less for the power-on condition and less still with the flaps full down but never reached zero. With the flaps full down, the effective dihedral decreased somewhat at higher angles of sideslip.

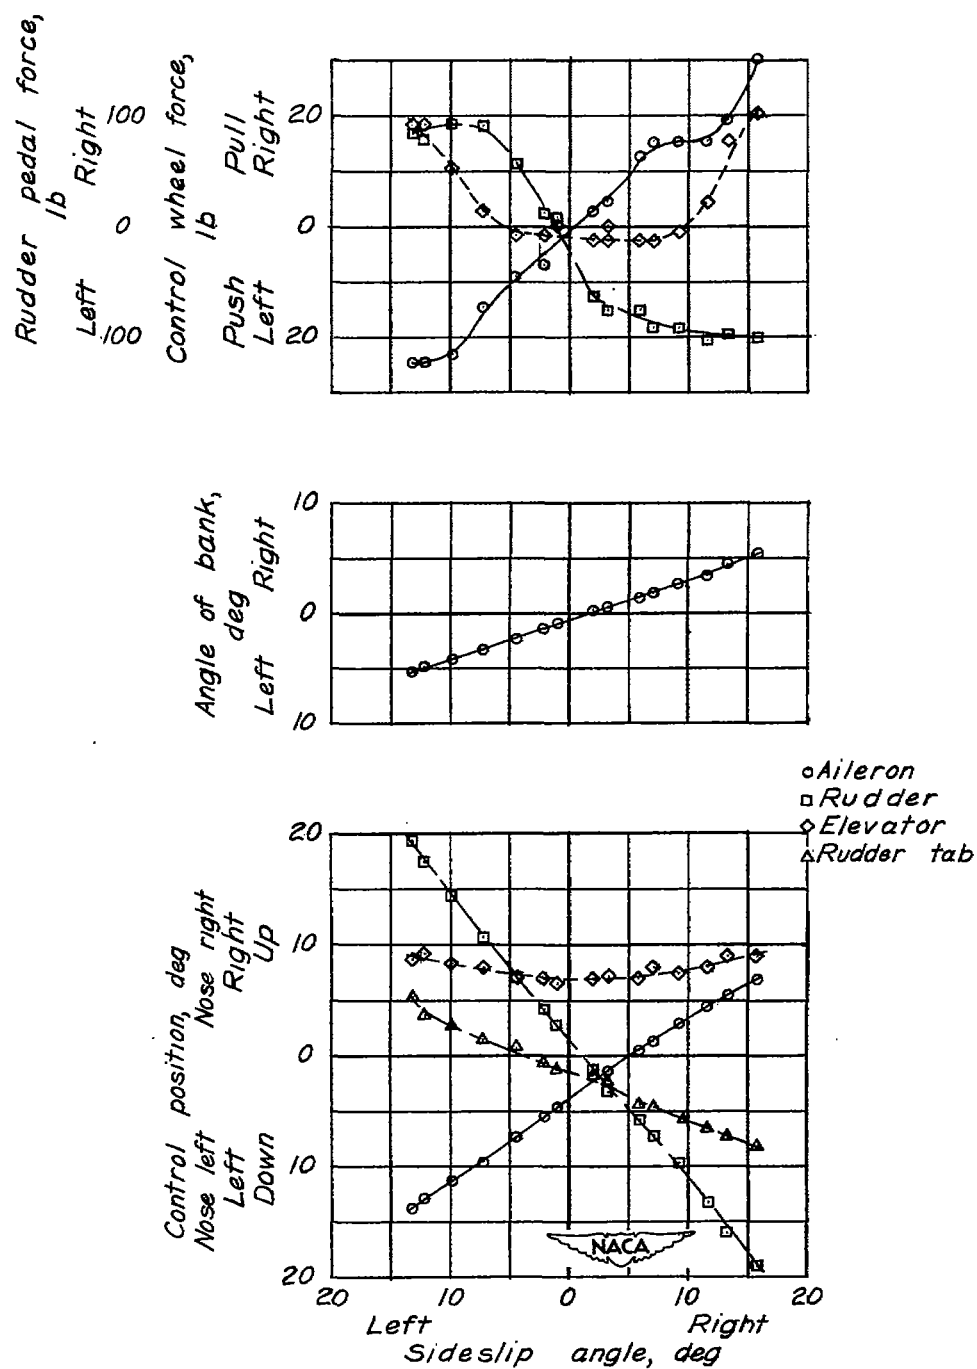
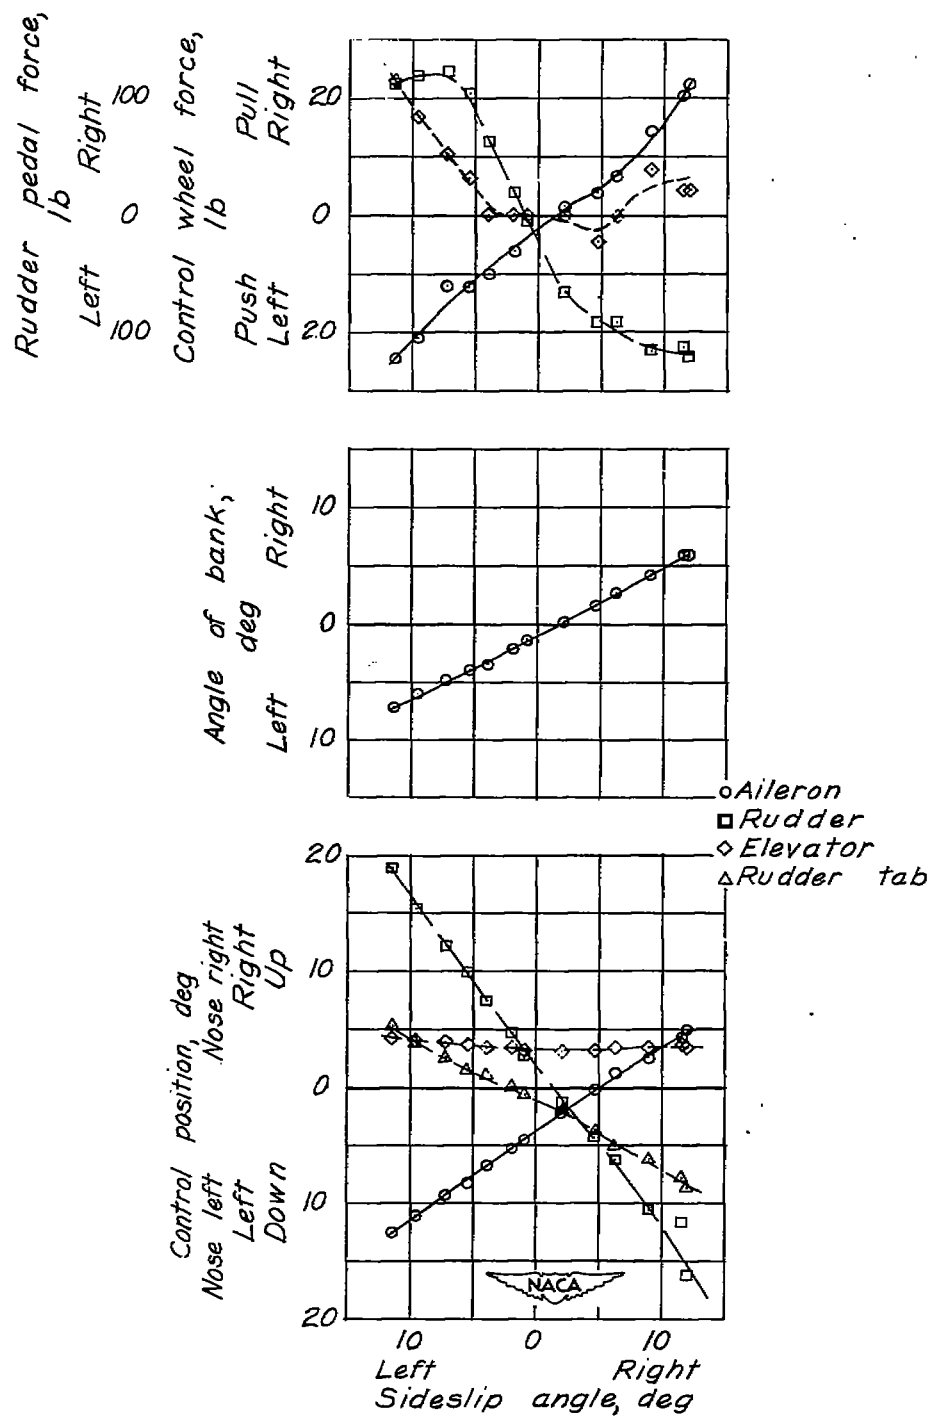
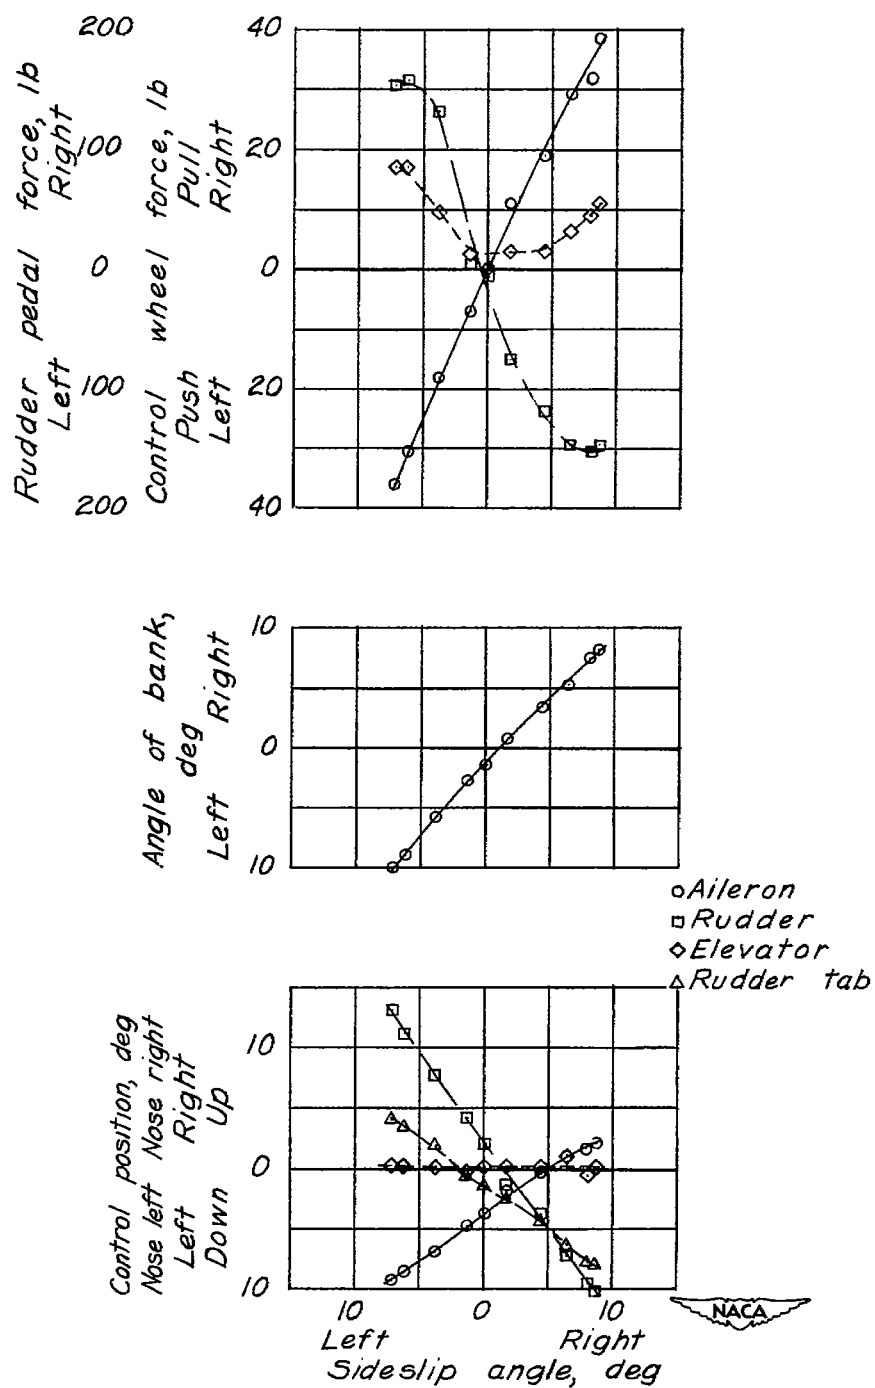
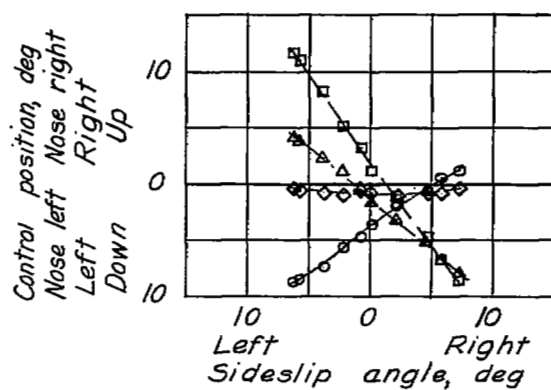
Figure 10.— Sideslip characteristics. C-54D airplane; flaps and gear up; power off.

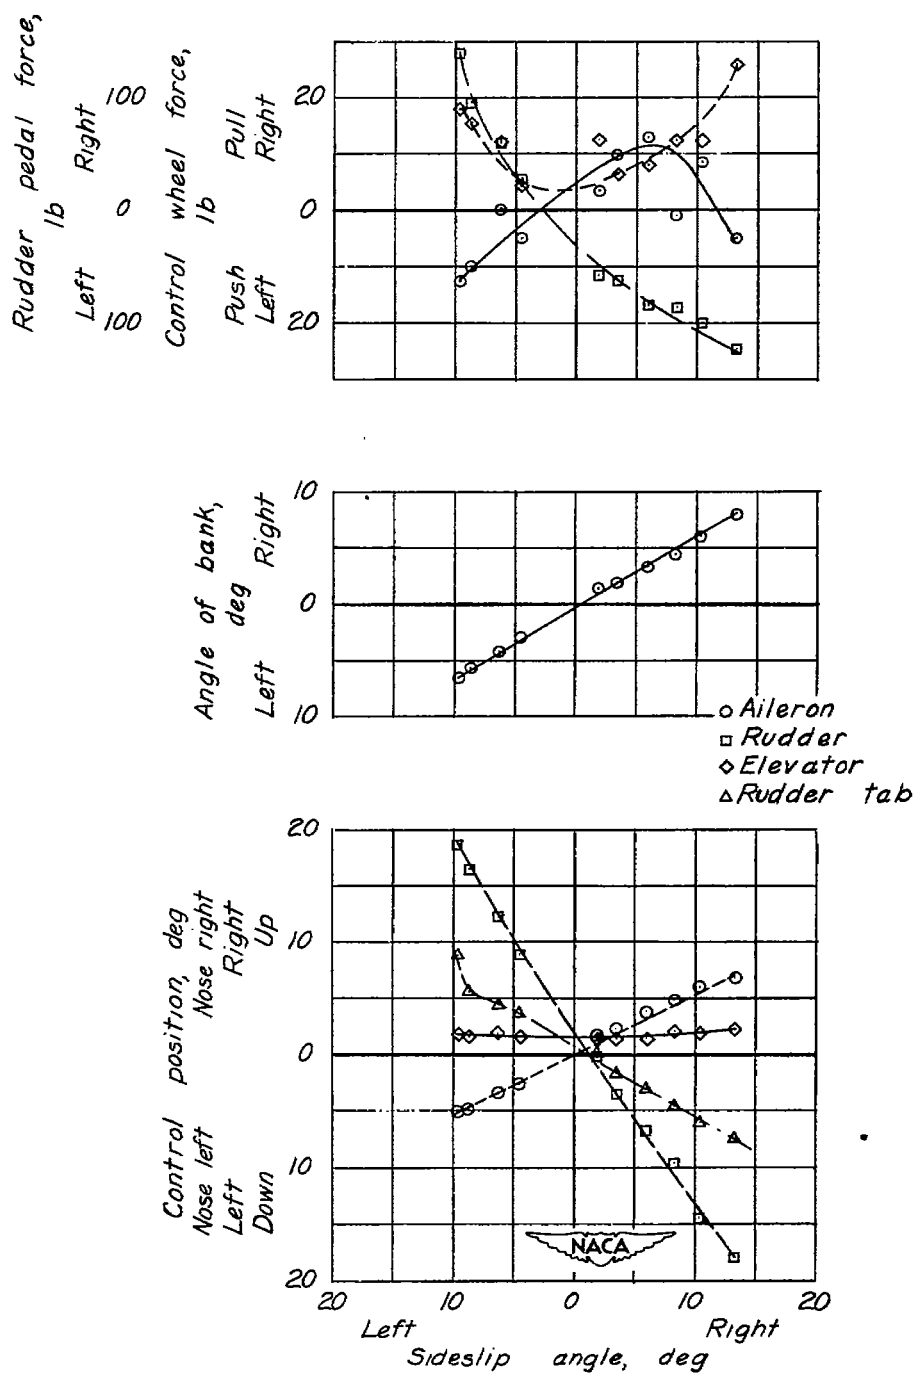
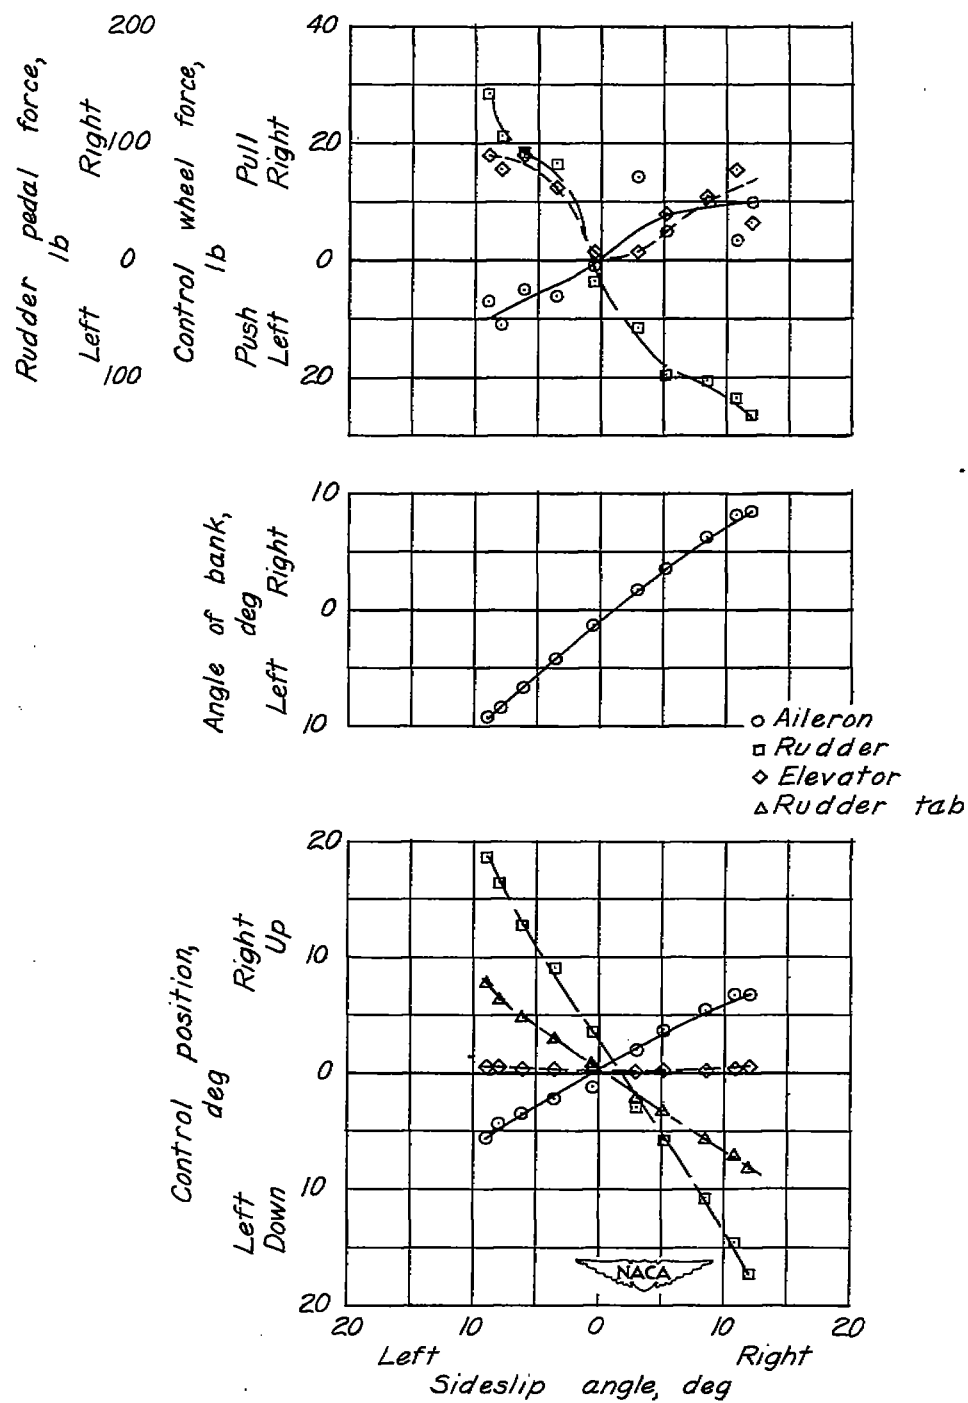
Figure 11.— Sideslip characteristics. C-54D airplane; flaps 20°; gear down; power 20 in.; 2550 rpm.

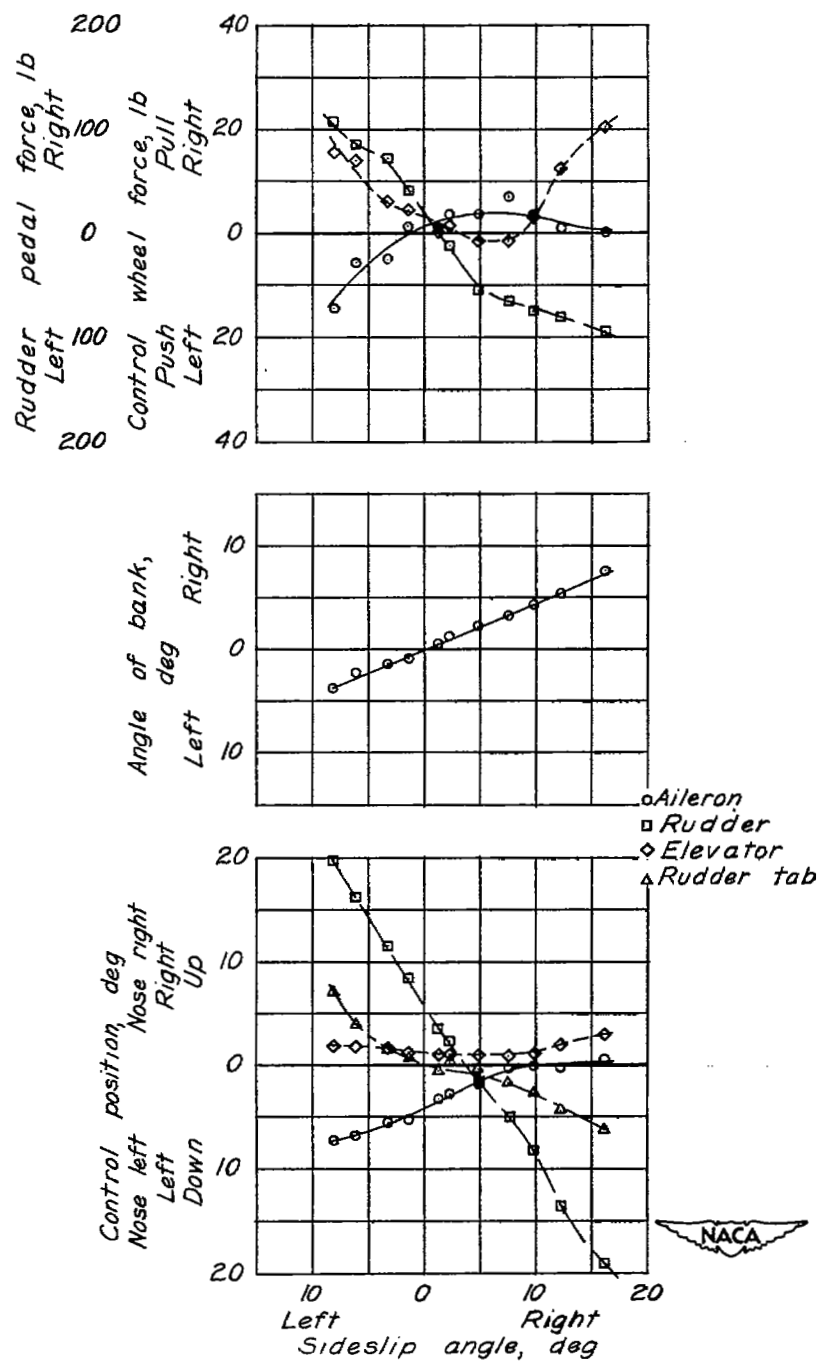
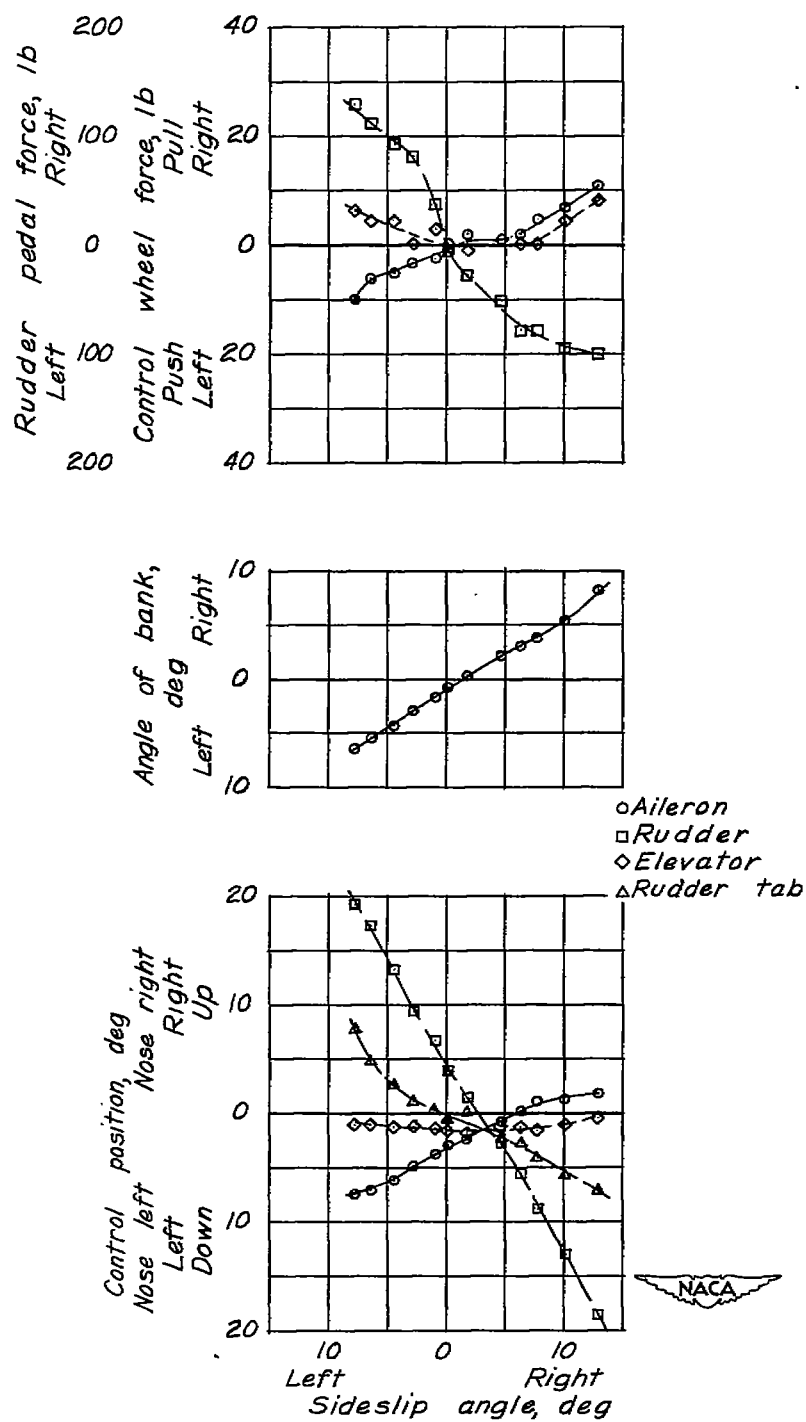
Figure 12.— Sideslip characteristics. C-54D airplane; flaps and gear down; normal rated power.

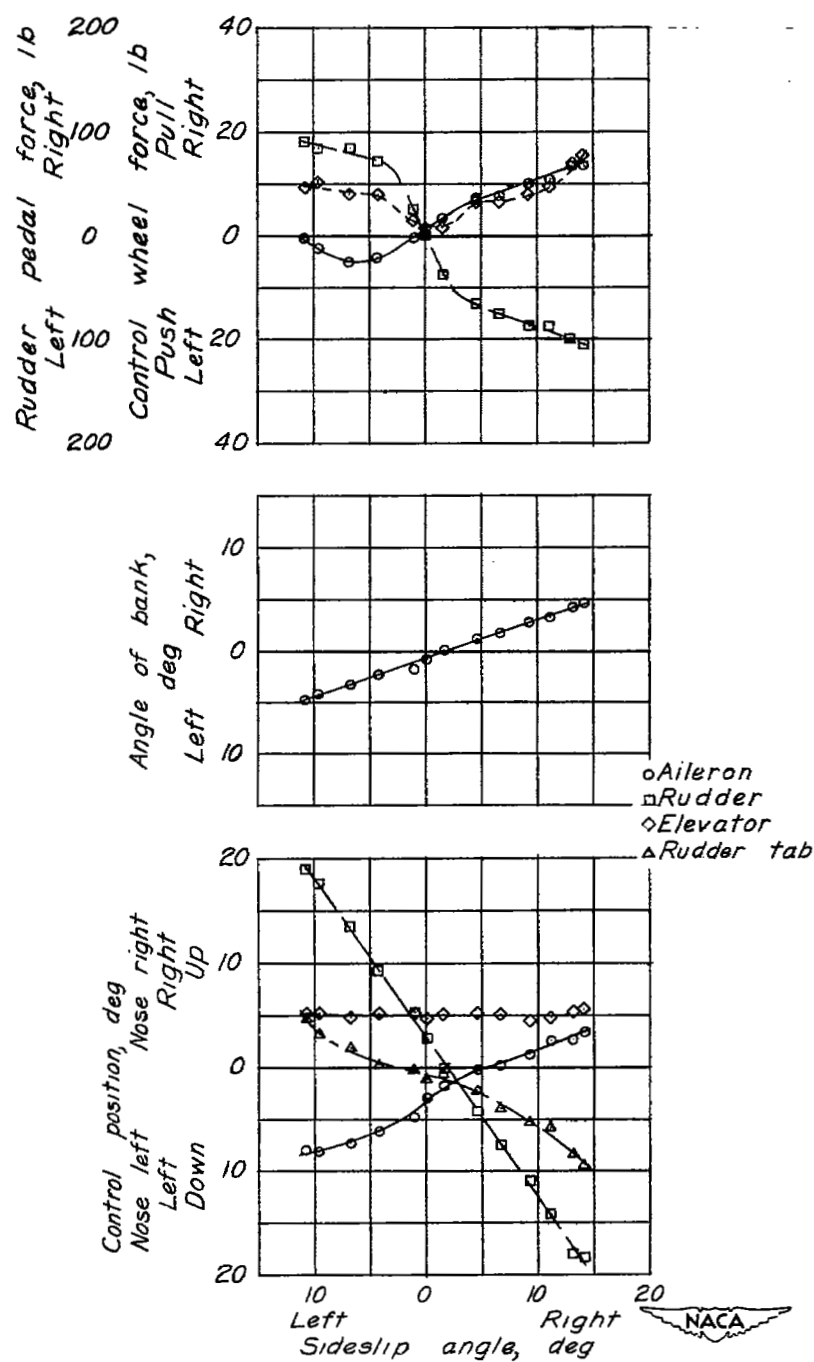
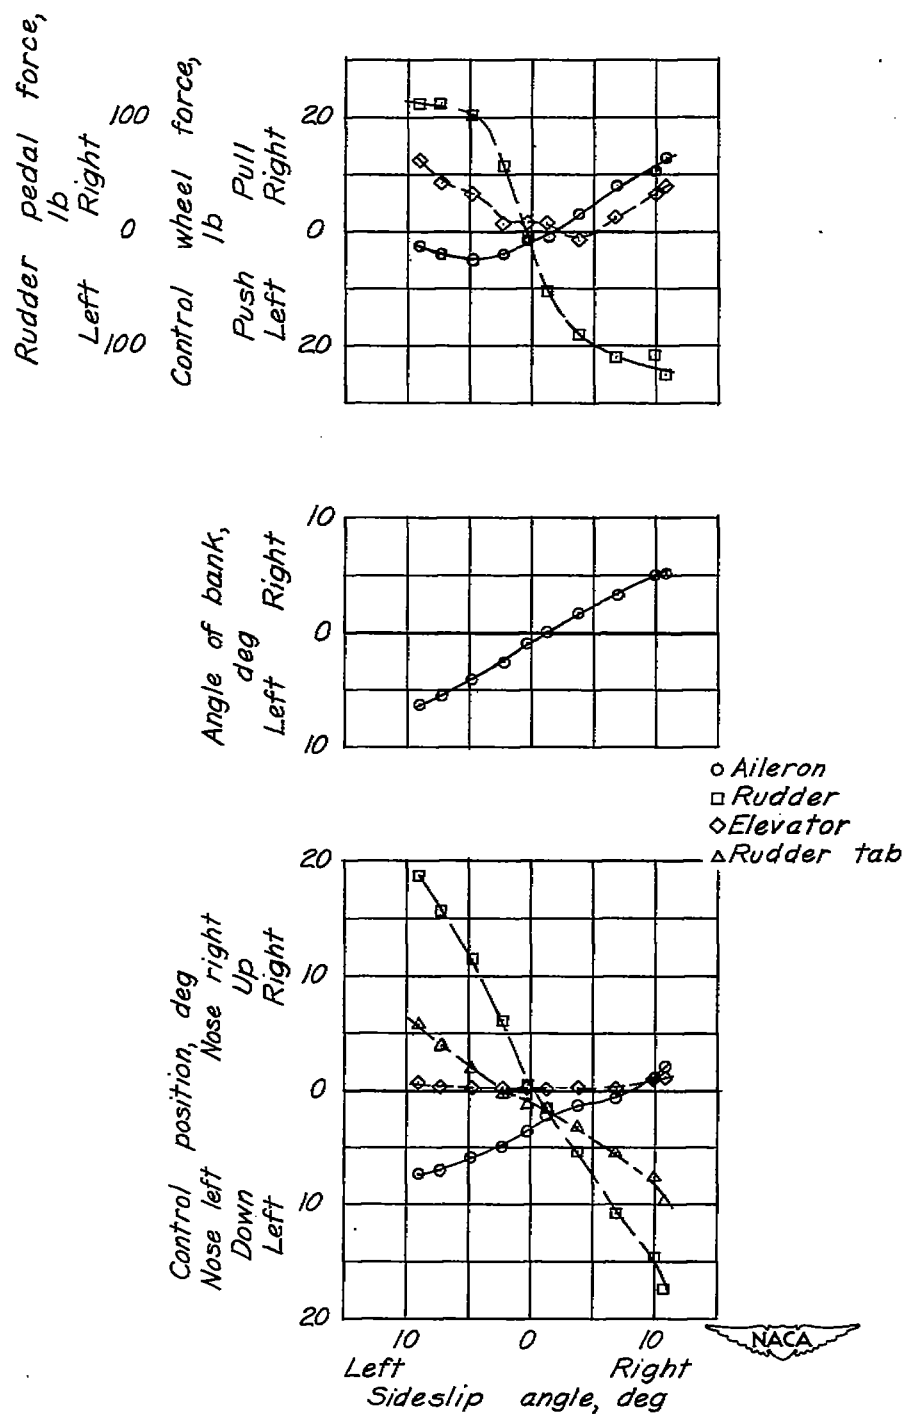
Figure 13.— Sideslip characteristics. C-54D airplane; flaps and gear down; power off.
